NAVORD REPORT 2932

INVESTIGATION OF MARK 18 TORPEDO FAILURES

25 AUGUST 1953

By:
Richard H. Stresau
L. E. Starr

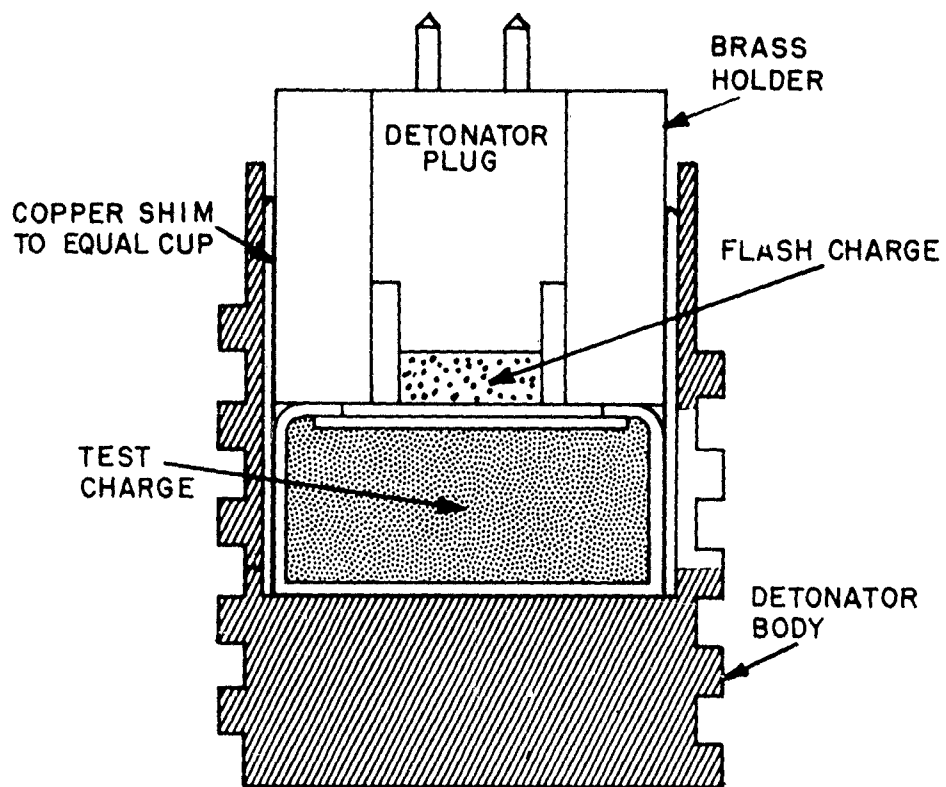
FIG.9 TEST SETUP FOR SPECIAL DETONATOR

21. The results obtained with the mercuric fulminate when initiated by the electric initiators, Figure 9, would seem to contradict the opinion stated above. However, the electric initiators used contained 25 mg of lead azide which is ample to establish detonation in this material. It would seem that one of the first results of deterioration of mercuric fulminate is the reduction in its tendency to make the transition from burning to detonation. It is known that very small changes in loading density can have large effects upon this tendency. The considerable effect of a small amount of dextrin in lead azide is an indication that impurities can also have a serious effect. The inescapable conclusion of these tests is that the major source of the low order action observed in these and the Hawaiian tests is the mercuric fulminate base charge in the Mk 8 Mod 3 detonator.

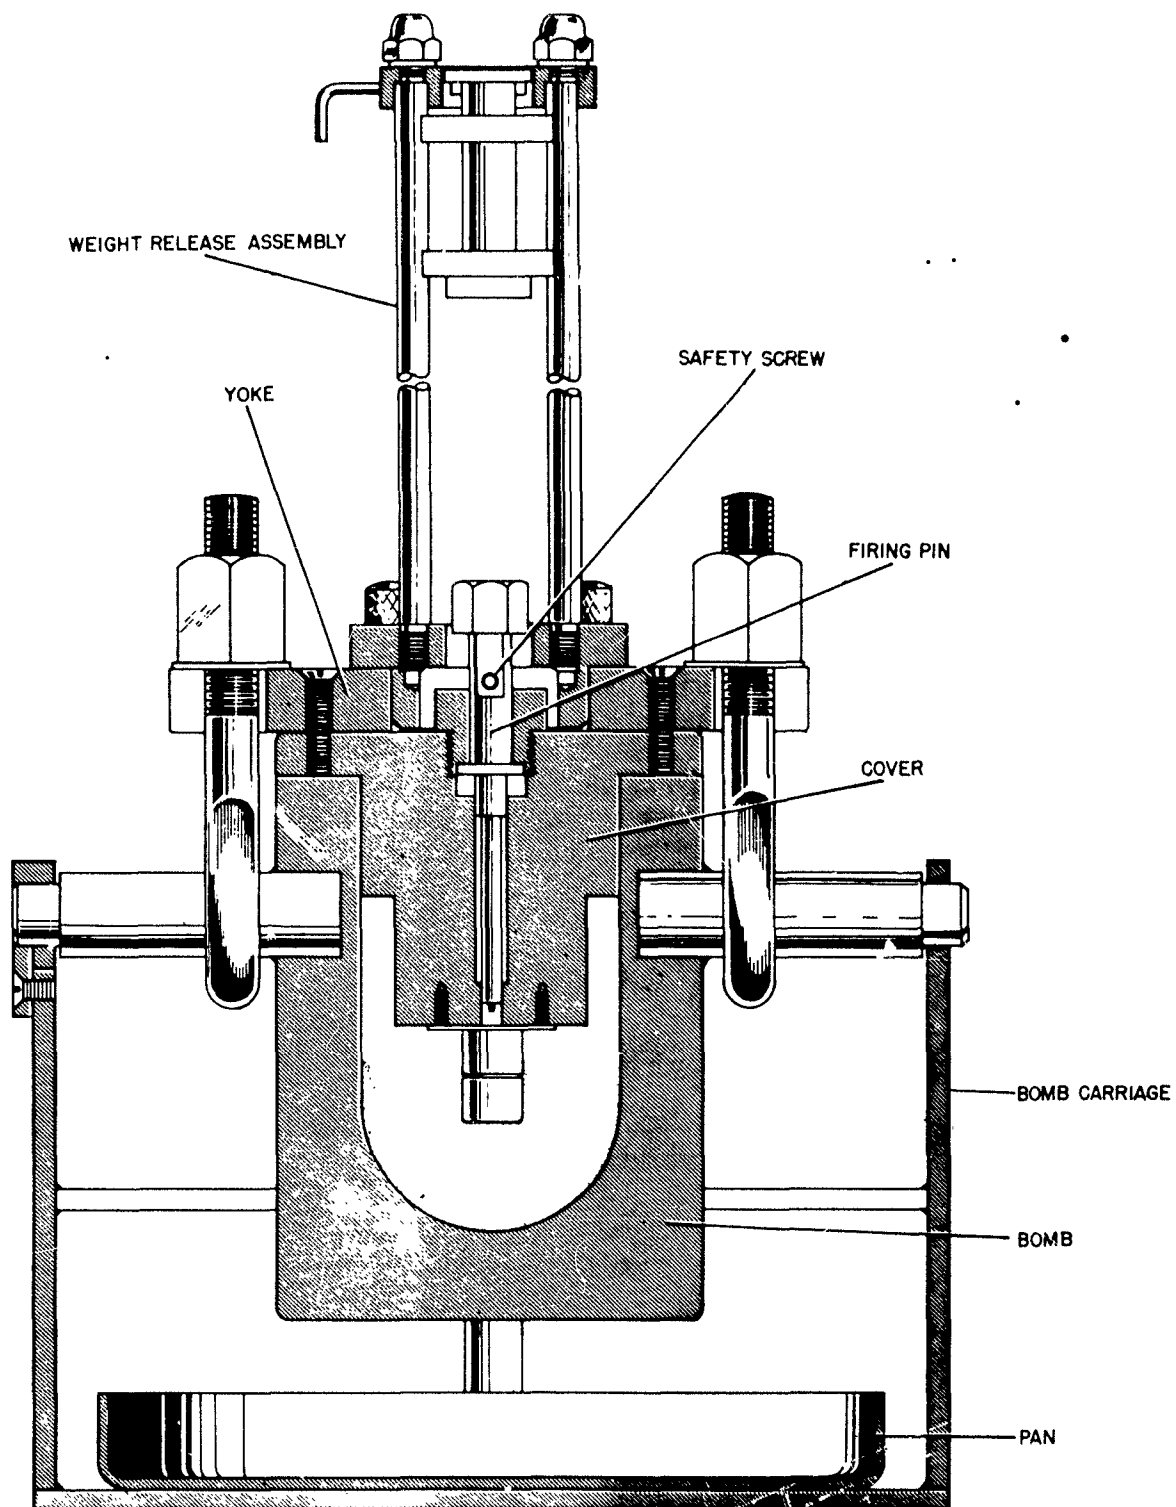
FIG. II
TEST SET MK 151 MOD 0 (SAND BOMB)

22. Sand tests of Mk 8 Mod 3 and Mk 8 Mod 4 detonators were made using the Test Set Mk 151, Mod 0, Figure 11. The results are given in Table II.

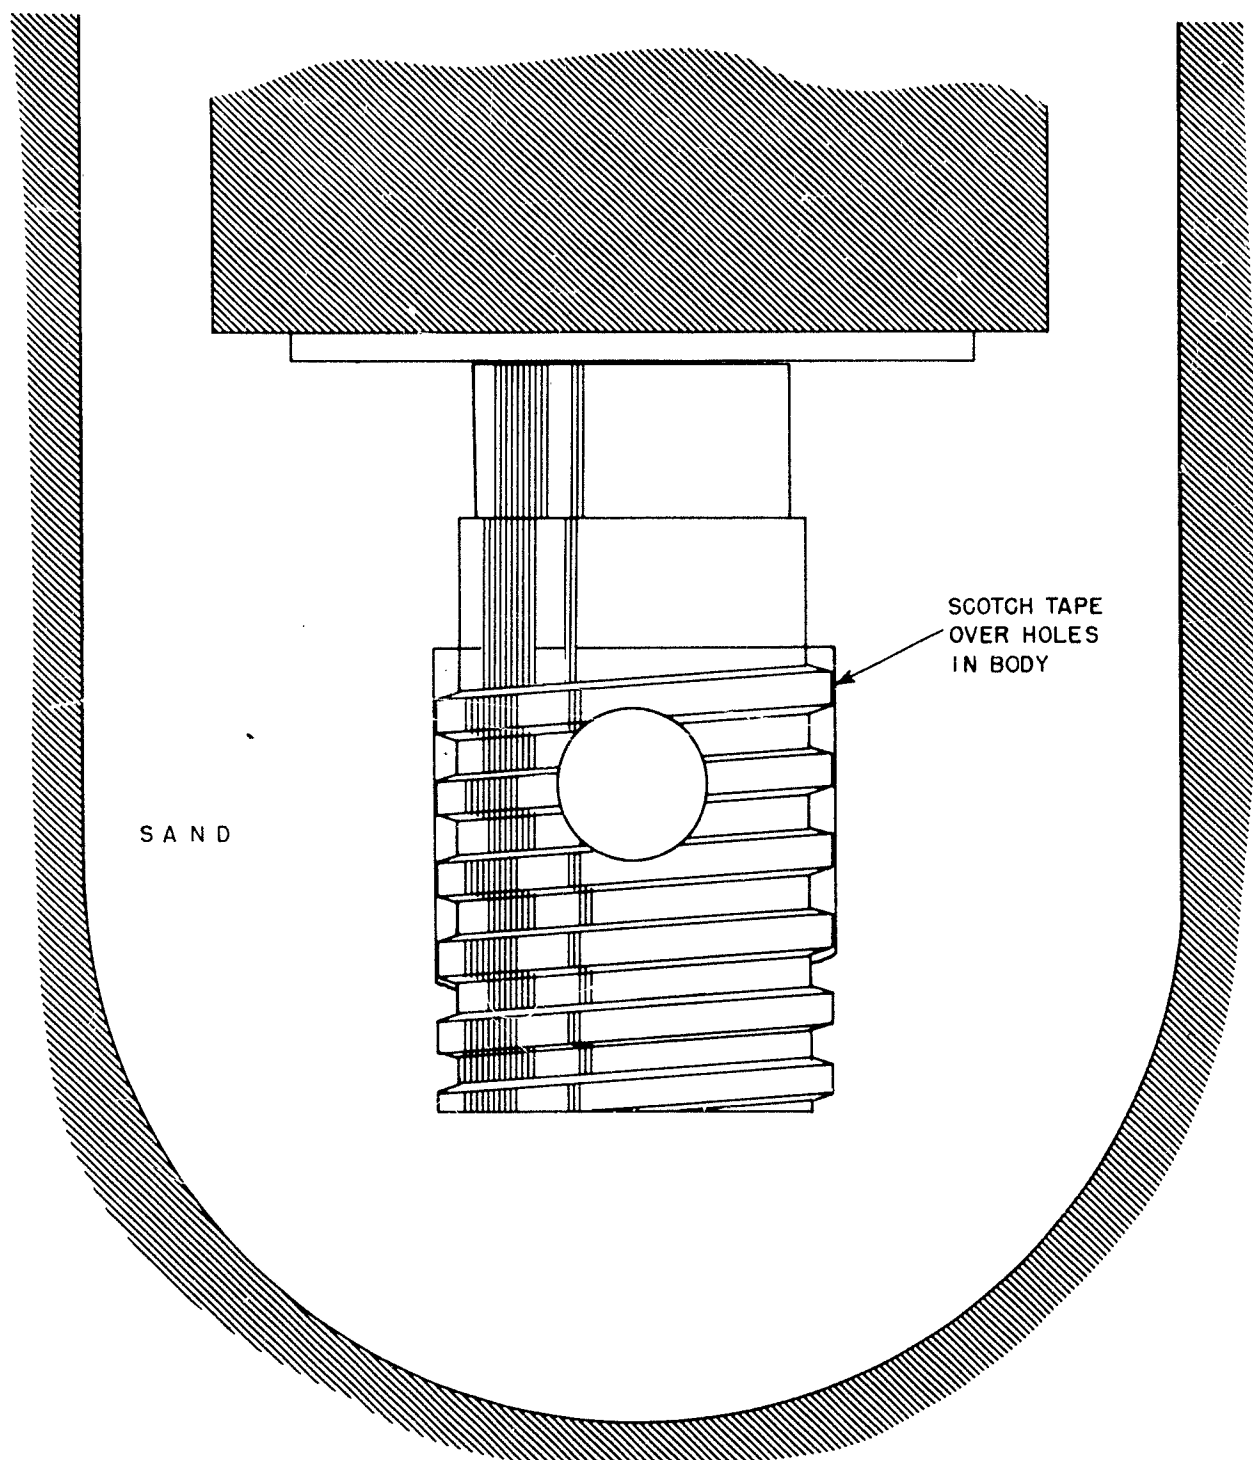
FIG.12 MK8 DETONATOR AS USED IN SPECIAL SAND TEST

24. One possible explanation for the good sand test results for detonators from the same group which produced low order detonation was that the sand afforded better confinement than the outer casing of the detonator which has four holes in the periphery and allows 1/16" or more clearance at the bottom in some instances. To check this possibility a series of sand tests was run with the detonators in their housings and with Scotch tape over the holes to prevent the sand from filling them and improving the confinement, Figure 12. The results of these tests are given in Table III.
